RE: 95V-203 Civic del Sol Passenger Side Airbag Module Recall

HONDA
SERVICE BULLETIN

Model	Applicable To	File Under	Bulletin No.
1994 DEL SOL	See VEHICLES AFFECTED	BODY	95-042
			Issue Date OCT 17, 1995

Recall: del Sol Passenger's Airbag

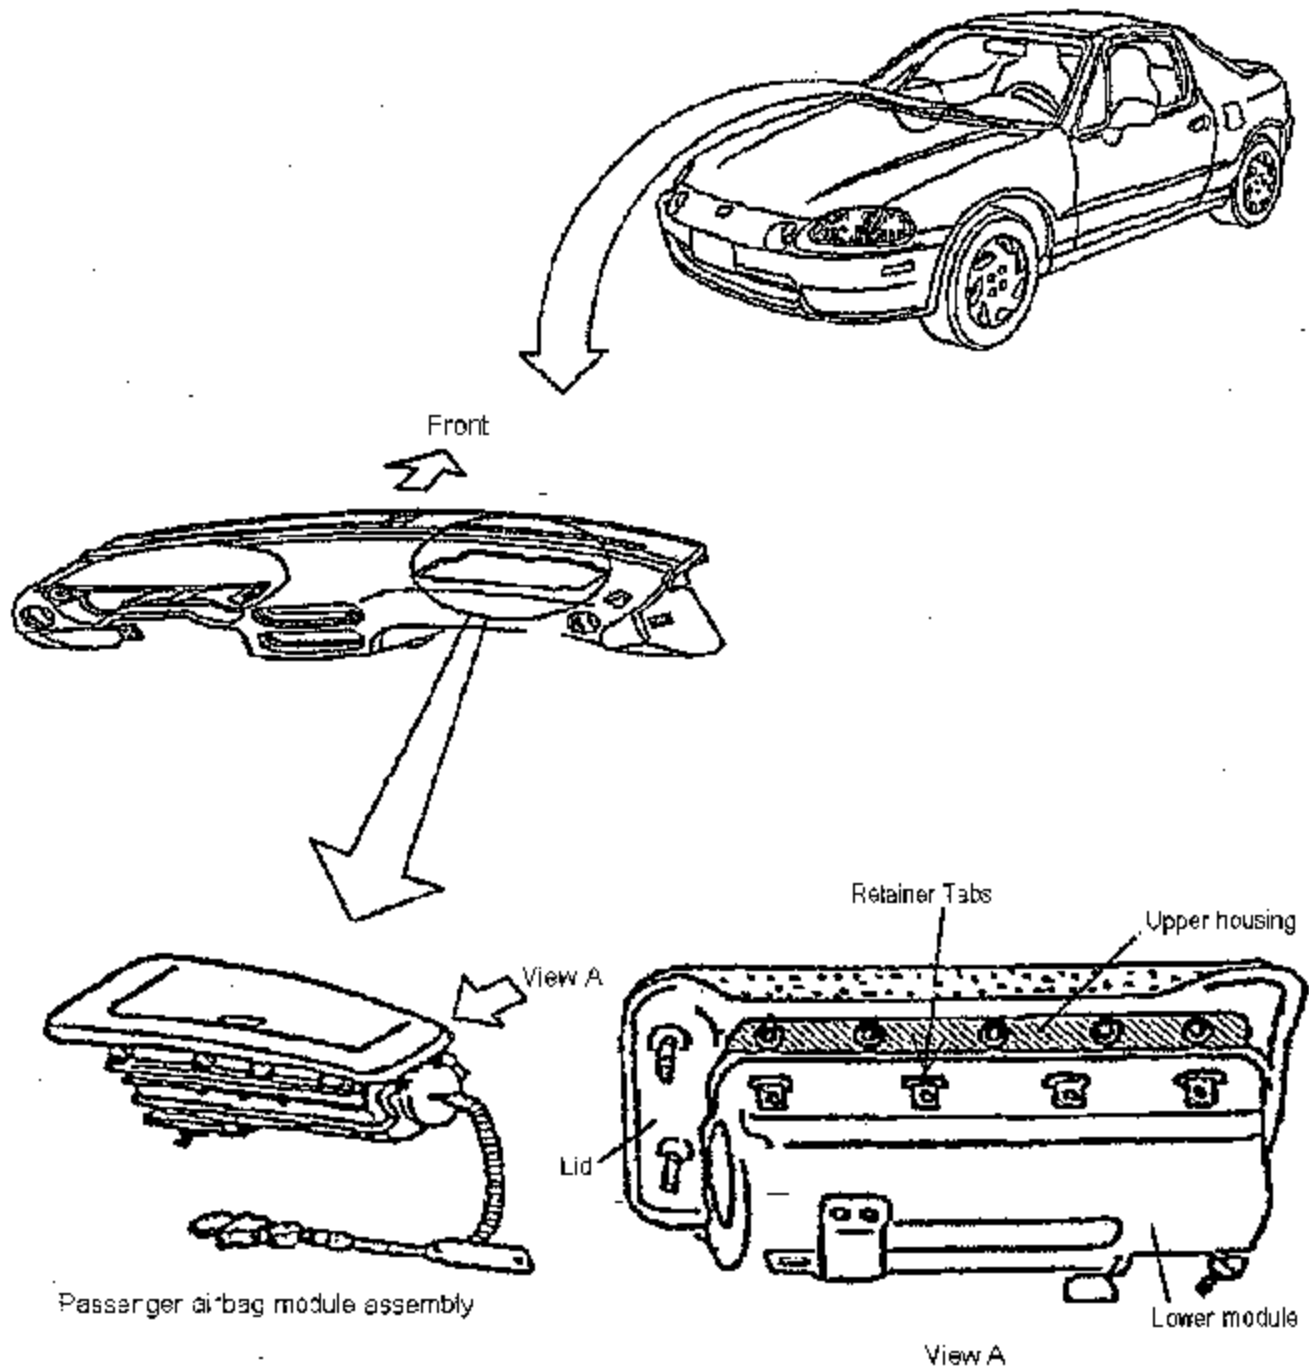
The passenger airbags installed in certain 1994 Civic del Sol's were manufactured improperly. The retainer tabs used to secure the lower module to the upper housing were drilled incorrectly. As a result, the retainer tabs may not have sufficient strength. This may allow the module to separate from the housing during deployment. If this happens, the airbag will not inflate properly, and a passenger would lose the benefits of a proper airbag deployment. (See attached drawing.)

Repair the airbag module assembly by adding reinforcement brackets.
